# GALVALUME®

## Proven Performance

# 25 years and beyond

## About the Inspection

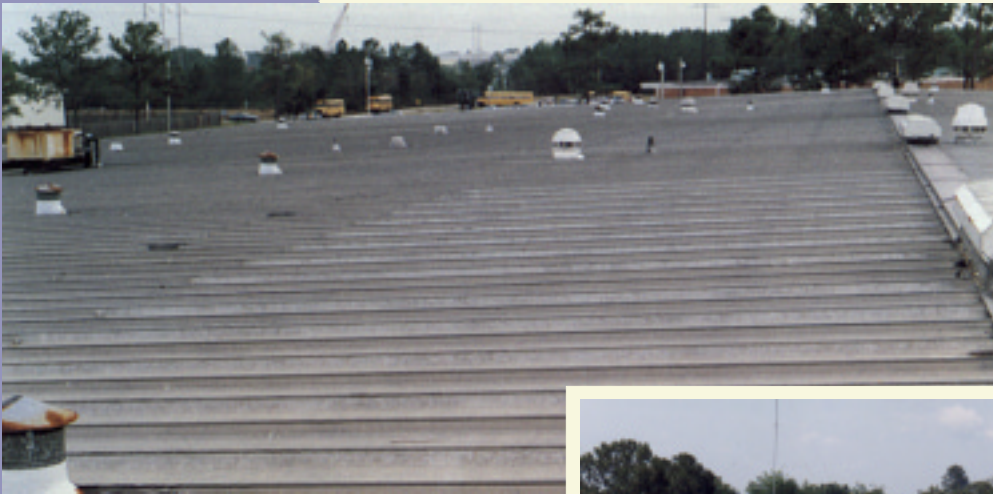
1994 photo

**T**he 1994 inspection photo above shows that the Galvalume SSR was in excellent condition after 20 years compared to the galvanized ancillaries, which were heavily rusted. The 1999 inspection photo above shows that the same Galvalume SSR continues to perform well after 25 year of service in the humid and wet marine environment on the Gulf Coast. It is projected that this 1/2:12-pitch roof should easily last another 10 years without major maintenance.

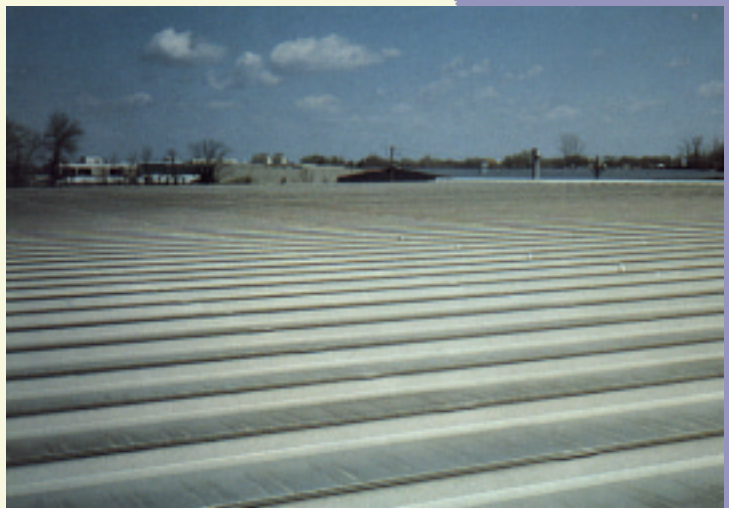
1994 photo

**T**he 1999 inspection of this 1/4:12-pitch Galvalume SSR confirmed that there has been little change since the 1994 inspection. The Al-Zn coating, which is more than 25 years old, was intact and protecting the steel base. In contrast, many of the galvanized ancillaries were heavily rusted. This roof, which is located near paper mills, is predicted to last another 10 to 15 years without major maintenance.

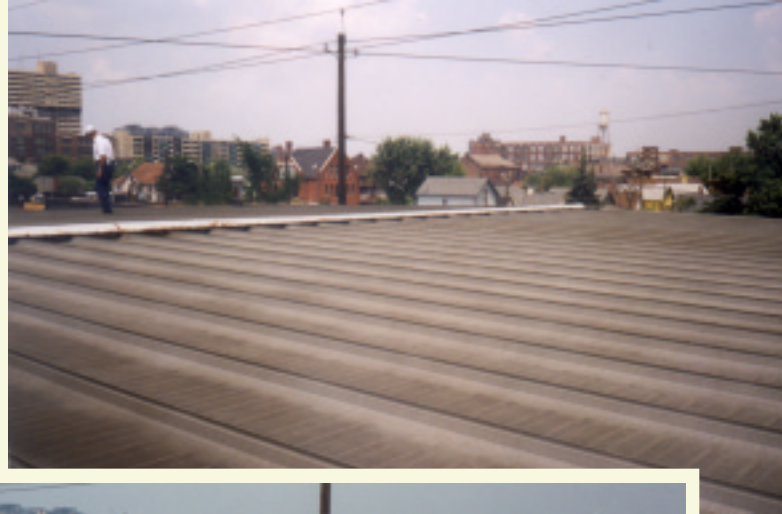
1994 photo

**T**he Galvalume SSR on this building is more than 25 years old, and is located in a light industrial area near downtown Indianapolis. The surface of the panels was dulled due to the accumulation of dirt and natural oxidation. Galvanized ancillaries were heavily rusted, but the Galvalume panels on this 1/4:12-pitch roof were in good condition. They are expected to last at least another 10 years in this acid rain, light industrial environment without major maintenance.

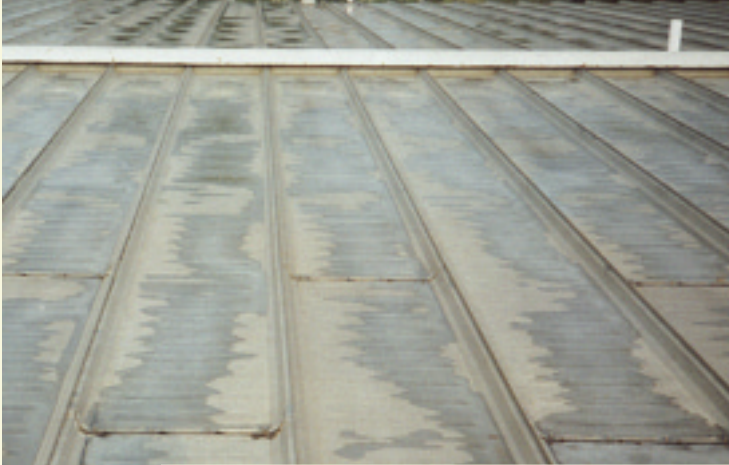
**D**espite the fact that this Galvalume SSR is located in an area with severe acid rain, this 1/4:12-pitch roof has continued to perform well after more than 25 years in service. The 1994 photo was taken in the early morning when the roof was wet with dew. The 1999 photo was taken in the afternoon after the moisture on the roof had evaporated. It is predicted that this Galvalume SSR will last another 10 years without major maintenance.

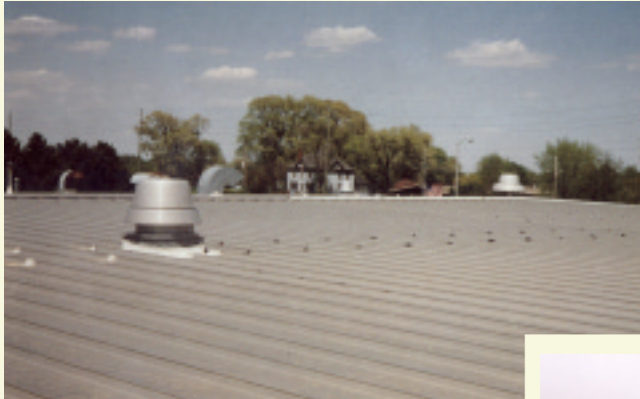
1994 photo

**T**he 1994 inspection photo above shows that the Galvalume SSR was in excellent condition after 20 years in service. The 1999 inspection photo shows that the same roof continues to perform well after 25 years of service. It is projected that this 1/2:12-pitch, Galvalume SSR will last at least another 10 years without maintenance, even in this industrial, acid rain environment.
